MAZDA RX-8 2004-2008

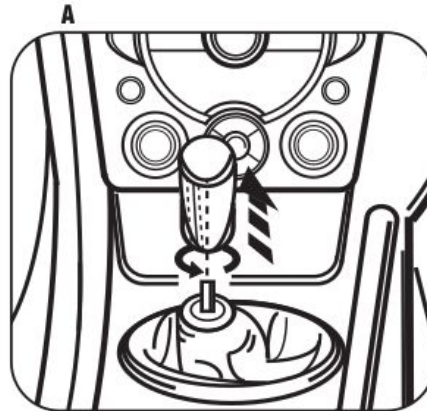
- 1** Disconnect the negative battery terminal to prevent an accidental short circuit.
- 2** Unscrew the shift knob counter clockwise to remove. (Figure A)
- 3** Unclip and remove the shifter trim panel. (Figure B)
- 4** Remove (2) Phillips screws from the bottom of the ashtray assembly then unclip and remove the assembly. (Figure C)
- 5** Unclip and remove the knee panel on the driver's side under the steering column (Figure D) then remove (1) 10 MM bolt from the side of the radio bracket. (Figure E)

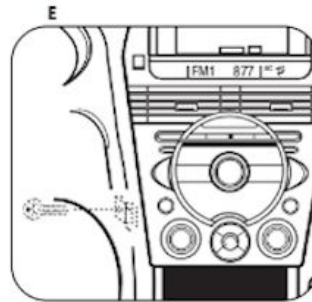
- 6** Remove (2) Phillips screws from the bottom of the radio/climate control panel. (Figure F)
- 7** Unsnap radio/climate control panel including radio chassis. Unplug and remove panel and chassis. (Figure G)
- 8** Remove (3) Phillips screws securing the factory display harness to the radio chassis. Unplug and remove display harness
- 9** Remove (4) screws securing the radio chassis to the radio/climate control panel. (Figure I)
- 10** Remove (6) screws securing the climate controls from the radio/climate control panel. Unplug and remove the climate controls.
