2000 S TYPE CLIMATE CONTROL REMOVAL INFORMATION

Center Control Console Removal

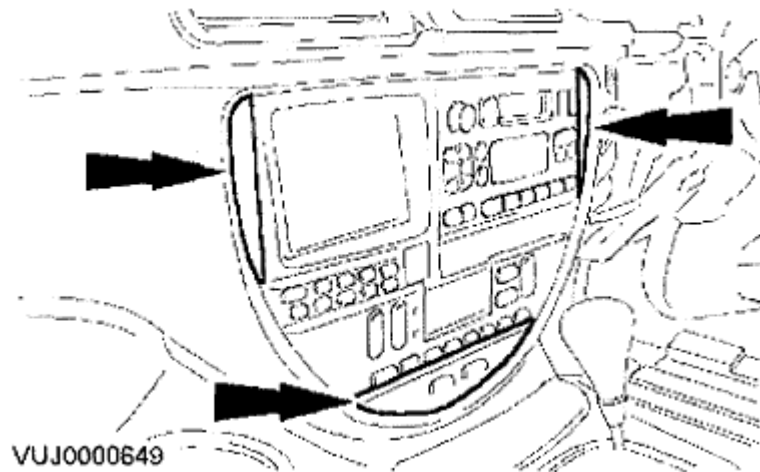
1. **Remove the center control panel screw covers.**

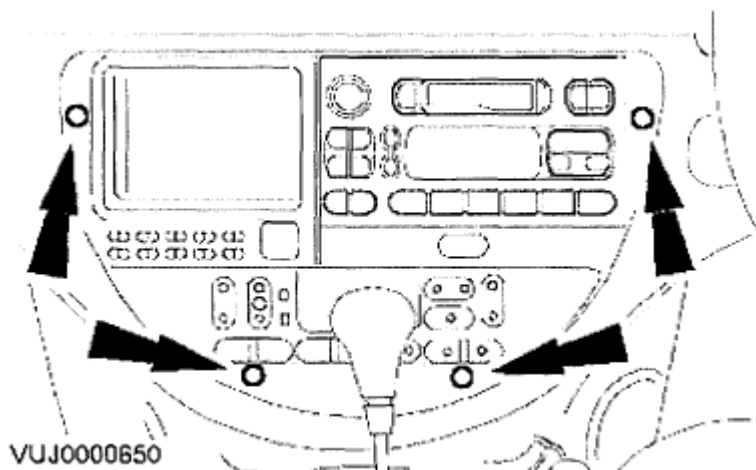
Detach the center control panel.

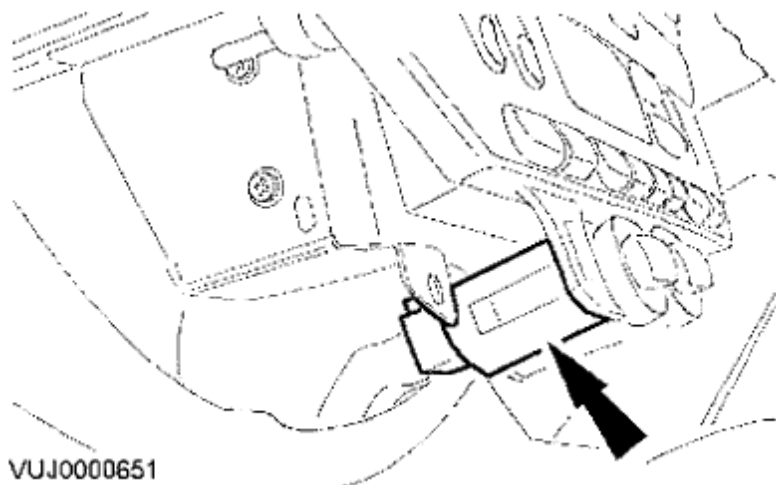
Disconnect the heated seat electrical connectors

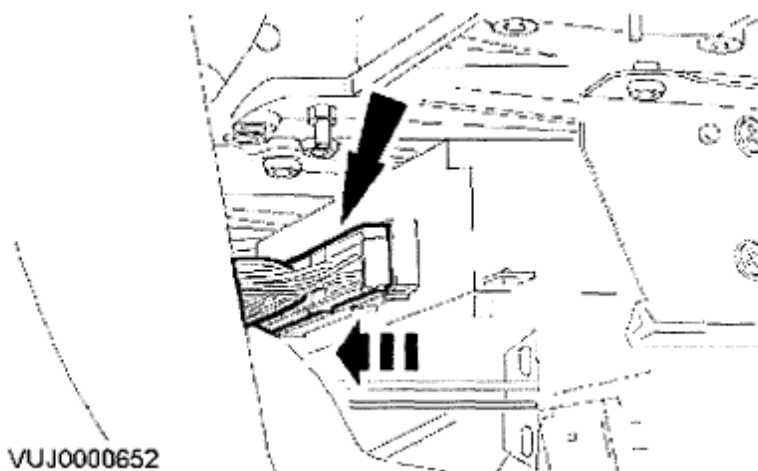
Disconnect the climate control unit electrical connectors

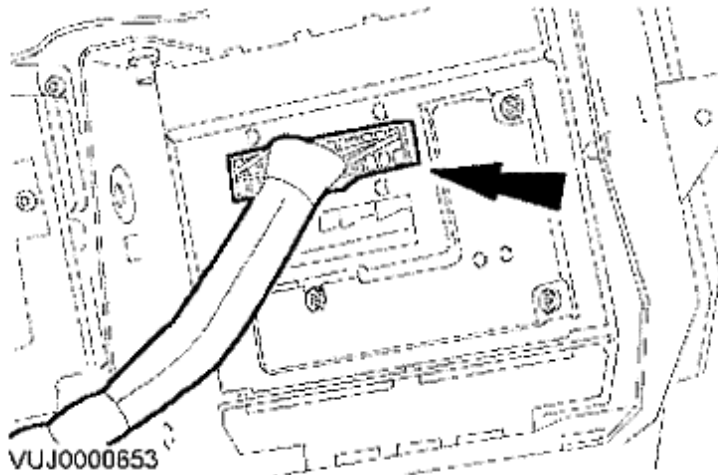
Disconnect the satellite navigation screen electrical connectors ,If applicable

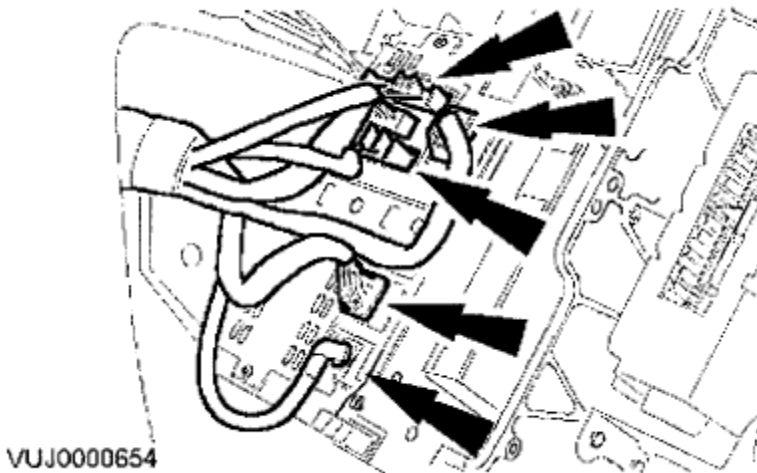
Remove the center control panel. Disconnect the audio system electrical connector.

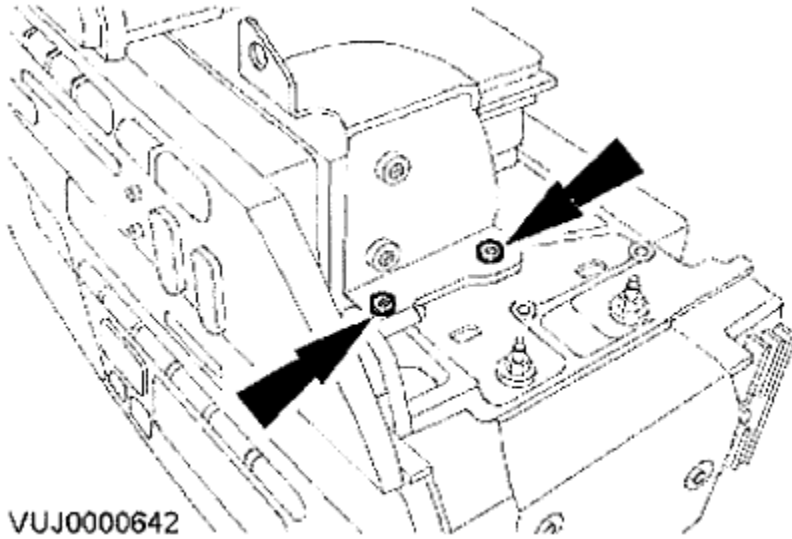
Remove the control assembly screws

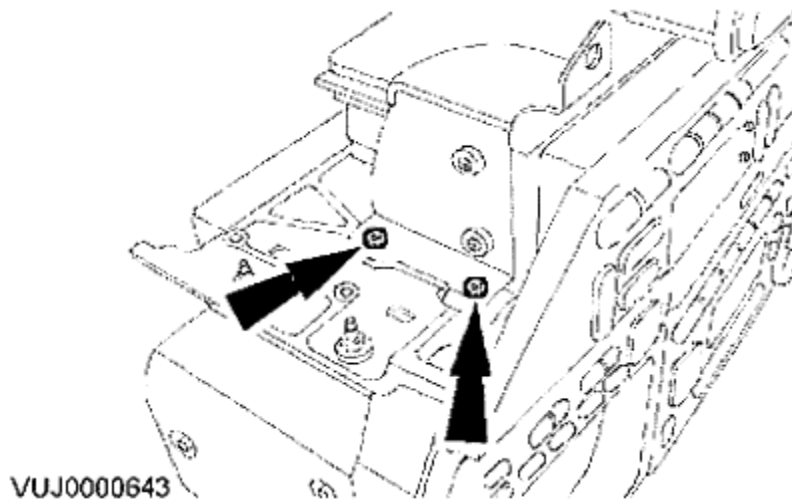
Remove the control assembly screws

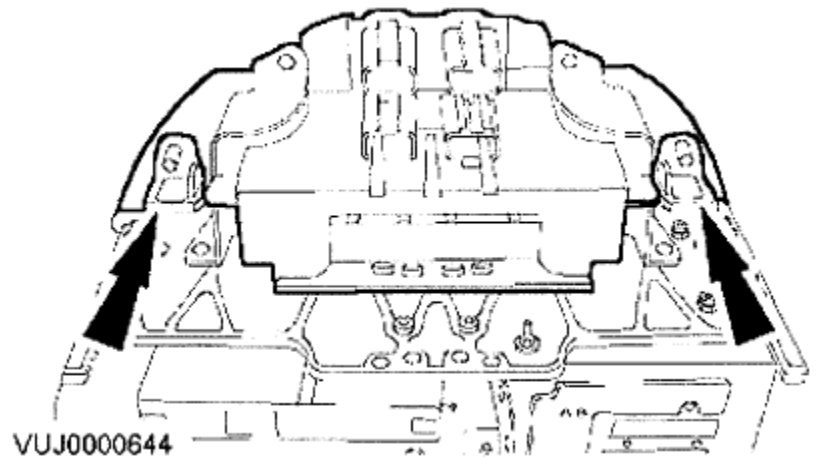
Remove the control assembly
