## 1998-2002 Mercedes ML320 ABS Assembly Removal

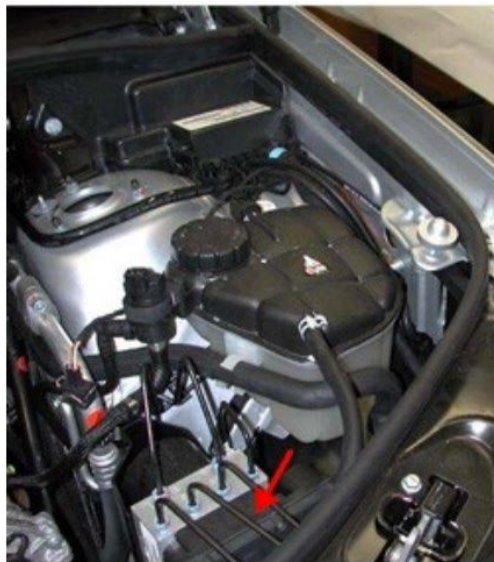
The solenoid pack is attached to the hydraulic unit located near the front left (driver's) side of the engine compartment (see red arrow). You will need to send the entire assembly for repair.

1. **Disconnect the negative battery cable.**
2. **Bleed off the brake fluid by attaching a hose to the bleeder valve on both a front and rear caliper.**
3. **Keep the brake pedal depressed using a brake pedal depressor.**
4. **Detach the brake lines attached to the HCU and label as shown (see next page).**
5. **Disconnect the electrical connector**
6. **Remove the ECU mounting bolts.**
7. **Remove the HCU.**

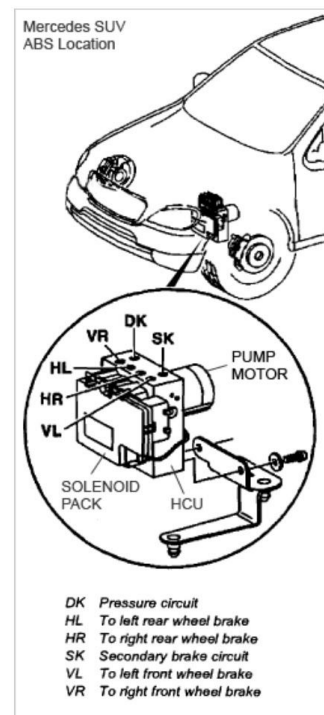
The ML320 uses separate modules for the solenoid valves and the ABS controller. The module attached to the hydraulic unit only contains solenoids.
