RANGE ROVER P38 CLIMATE CONTROL MODULE REMOVAL INSTRUCTIONS

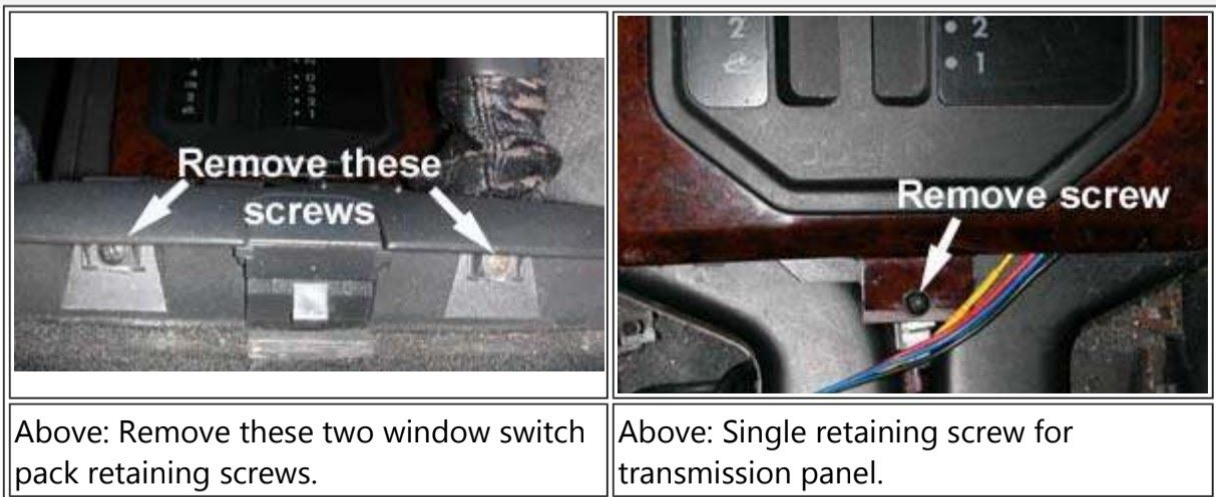
Open the centre console lid and remove the two fixing screws that retain the electric window switch pack in the centre console cubby box. These are located on the top front edge of the cubby box. The pack is retained by two flat spring steel tabs at the bottom. You can tilt it forward and pull it upwards to disengage them. To remove the pack completely, you would need to remove the handbrake grip, but this is not necessary to move the pack out of the way enough to get at the fixings for the gear selector surround.

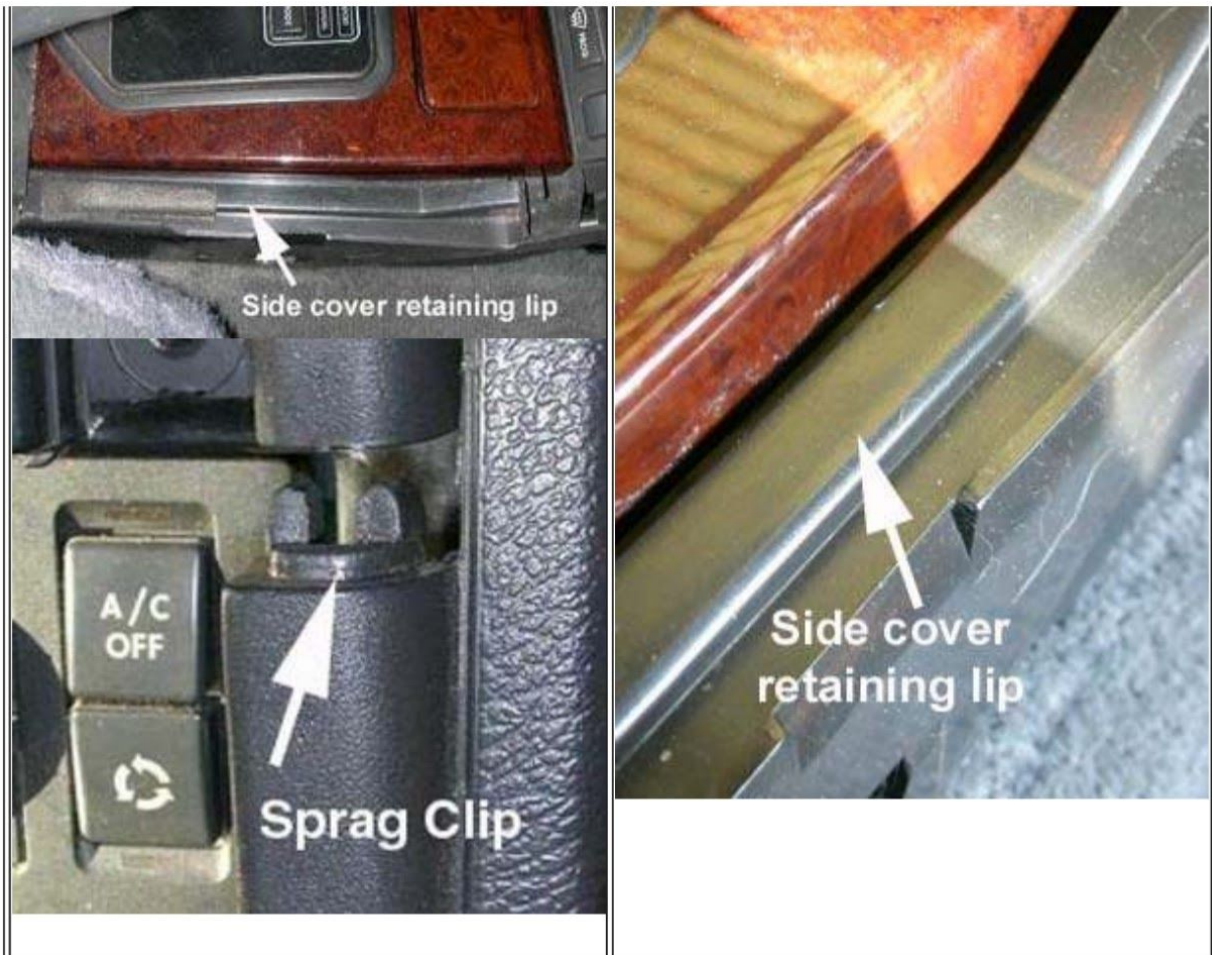
Now remove the single screw that holds down the rear edge of the gear selector surround. Lift the panel out - it is only retained by simple spring clips at the front - and unplug the cigarette lighter socket and the lamp and holder. You might want to replace this bulb whilst you have it apart - it is a standard 1.2 watt 12 volt wedge base bulb as used in the HEVAC and instrument panel. You can now, with your fingers or a screwdriver, pry the rear edge of the finishing panel up and sideways to get it over the retaining lip. See photos below. This will then allow you to slide the panel back and release the sprag clip from the switch pack panel. The intermediate photos (below) of the retaining lip were taken after removal of the side panel in order to illustrate this article.
